FULL RESERVE STUDY

Calabay Parc at Tower Lake Homeowners Association, Inc.

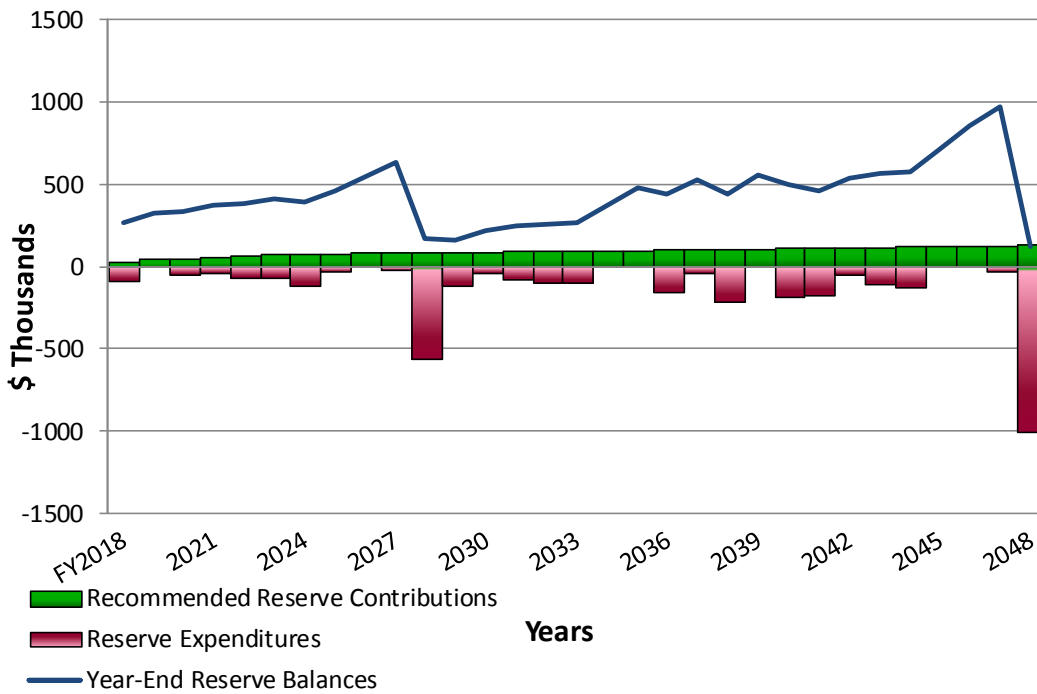
2. RESERVE STUDY REPORT

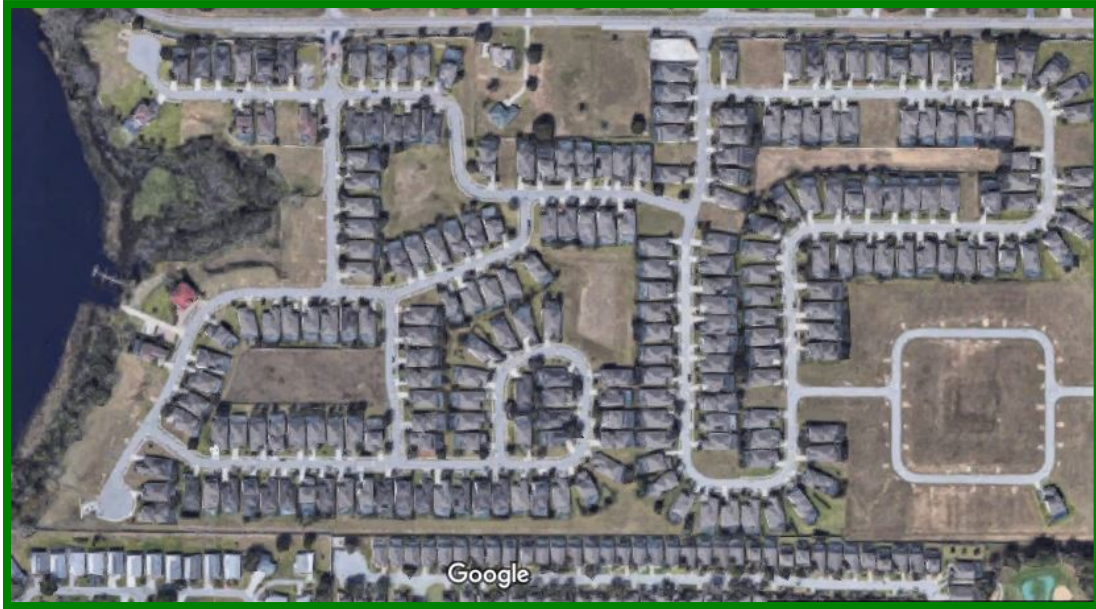
Our investigation includes Reserve Components or property elements as set forth in your Declaration. The Expenditure tables in Section 3 list the elements contained in this study. Our analysis begins by segregating the property elements into several areas of responsibility for repair and replacement.

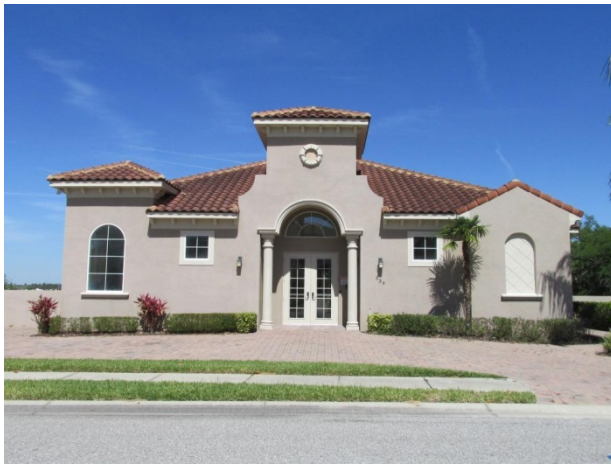
Front elevation of clubhouse

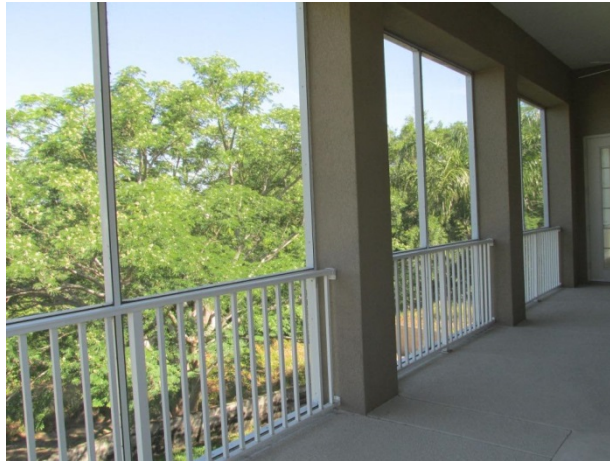
Balcony screen enclosure

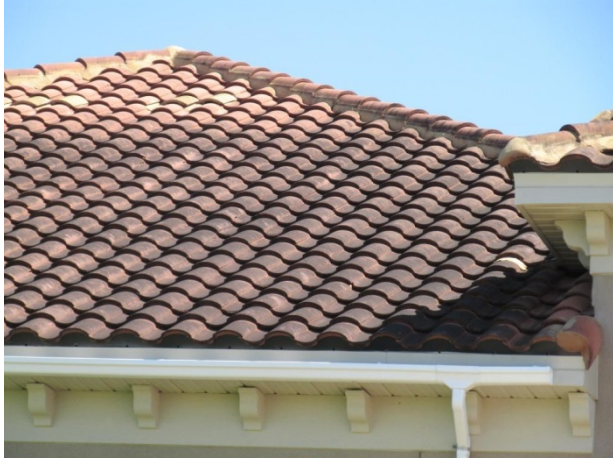
Concrete tile roof assembly

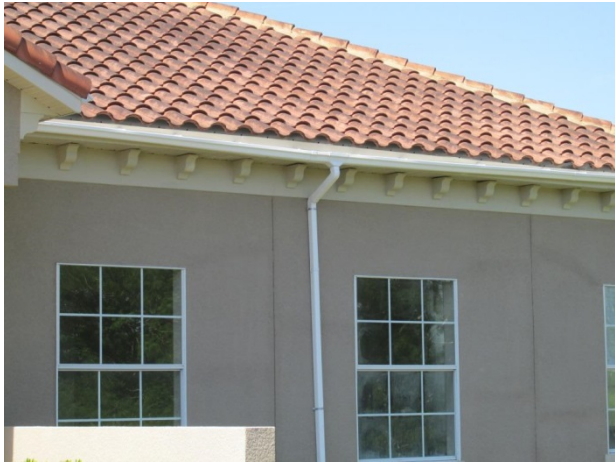
Stucco walls with cracks evident

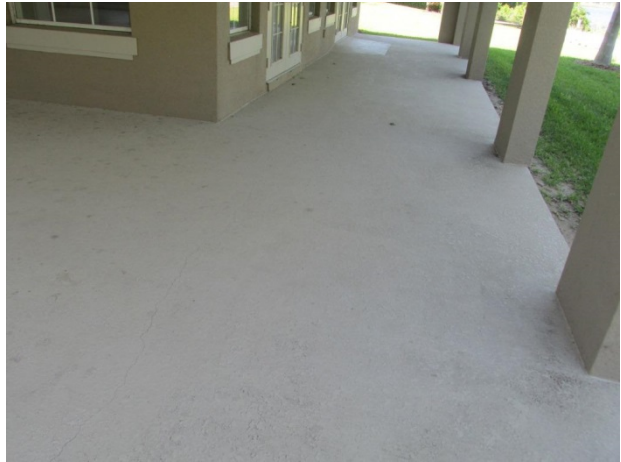
Patio floor surface with coating

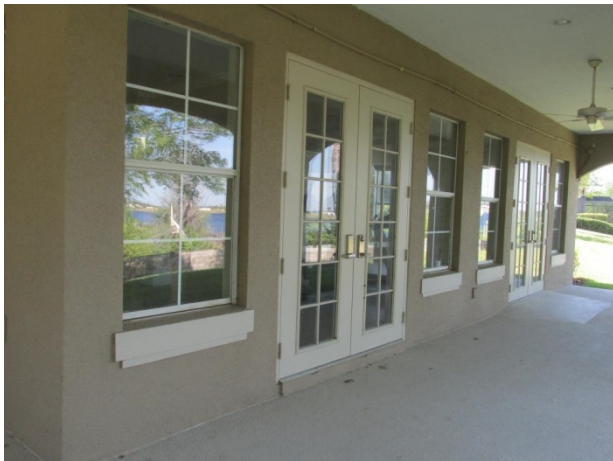
Condition: Good overall

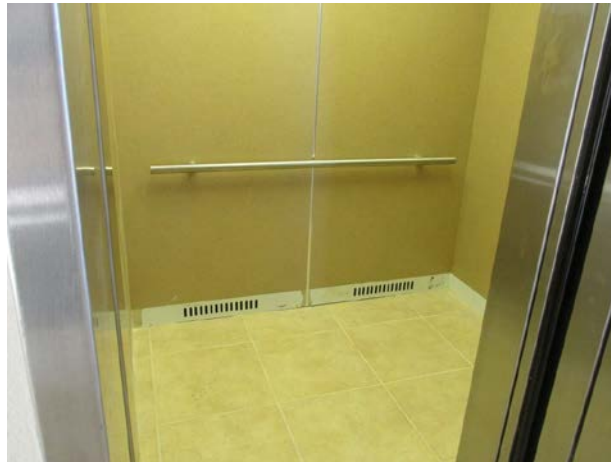
Elevator cab finishes

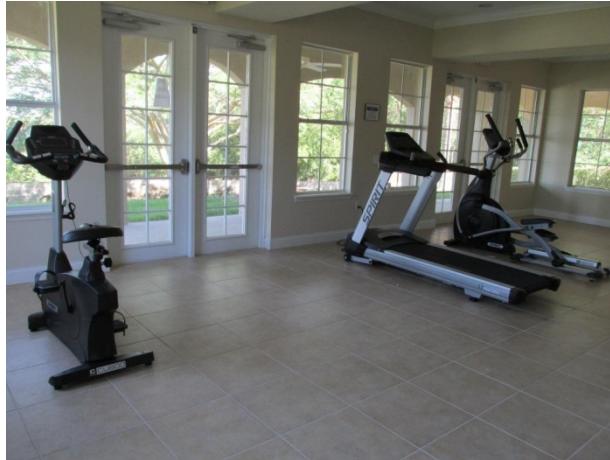
Conditions: Good overall

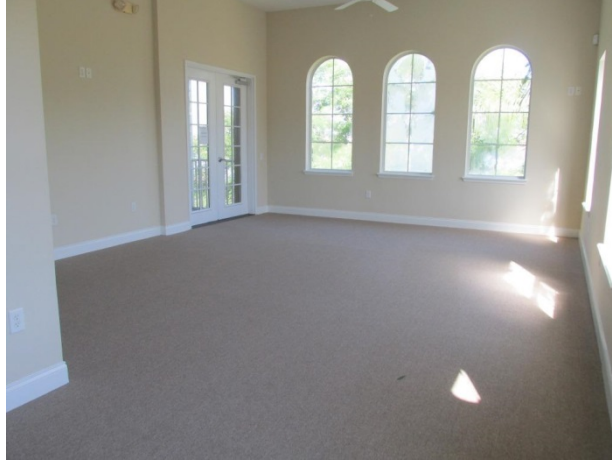
Carpet floor coverings

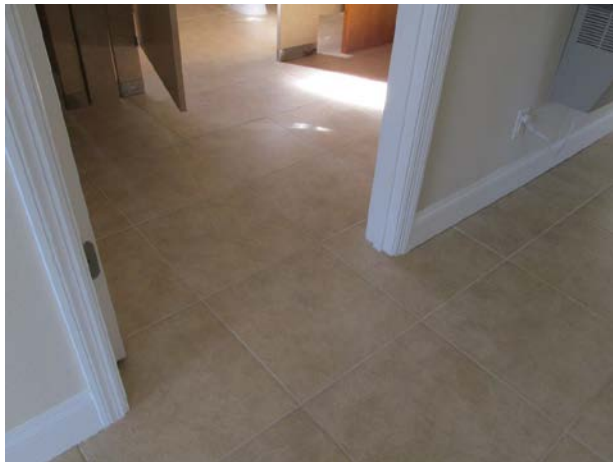
Tile floor coverings

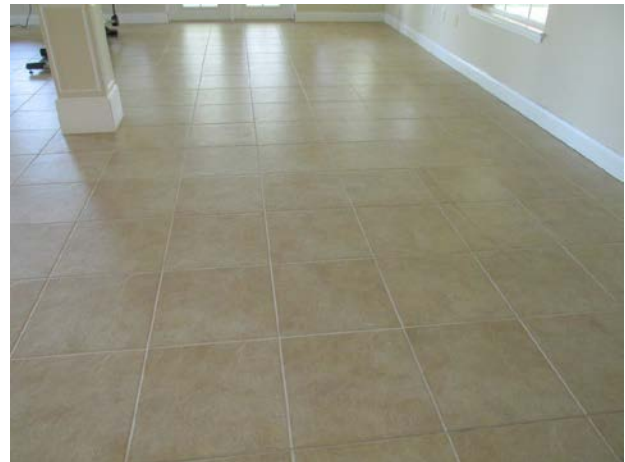
Tile floor coverings

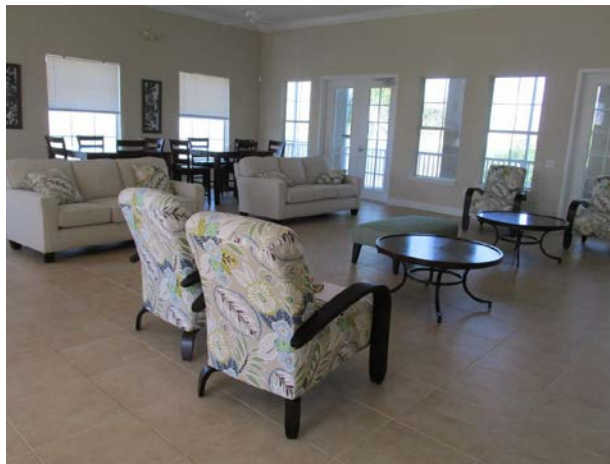
Condition: Good overall

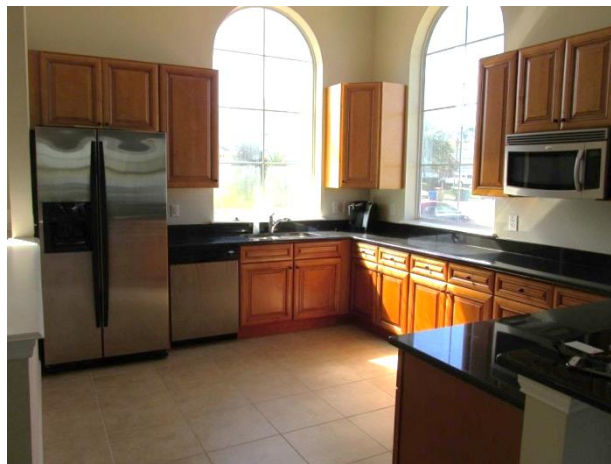
Condition: Good overall

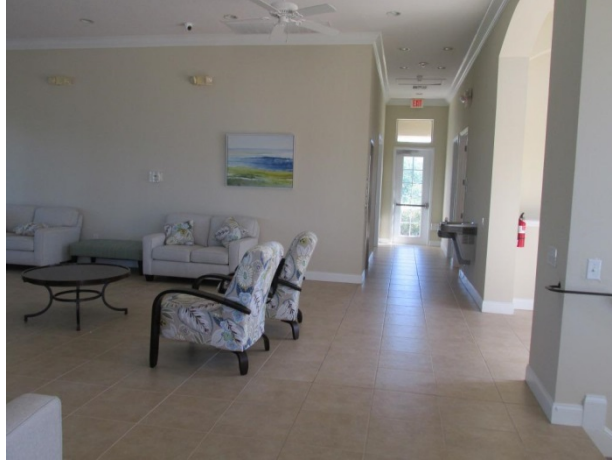
Condition: Good overall

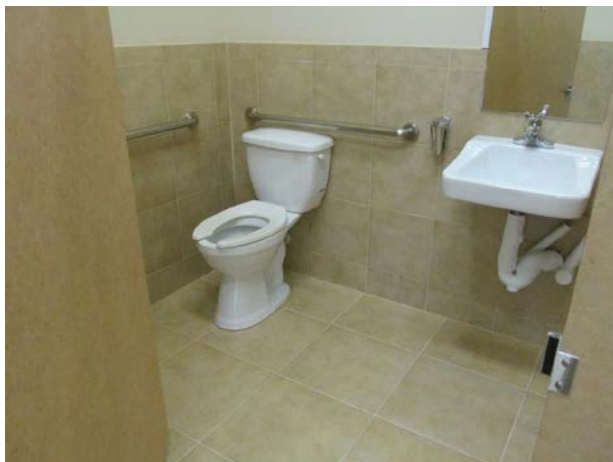
Condition: Good overall

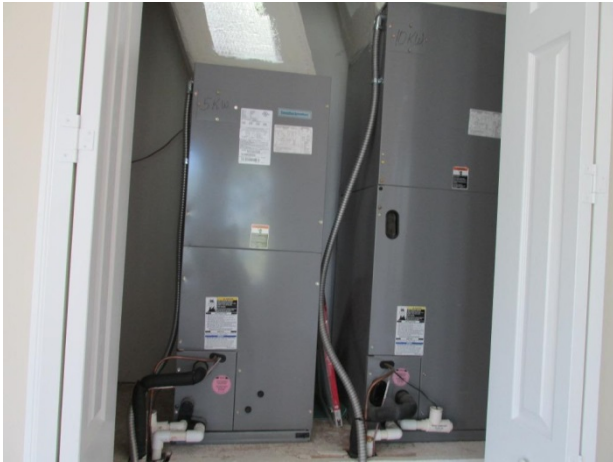
Condition: Reported satisfactory

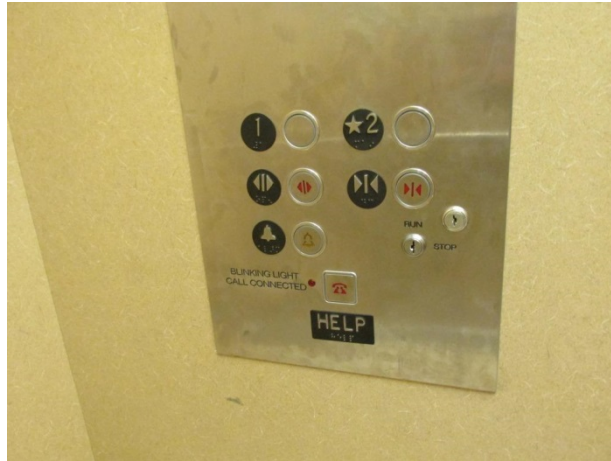
Condition: Reported satisfactory and service interruptions are reportedly infrequent.

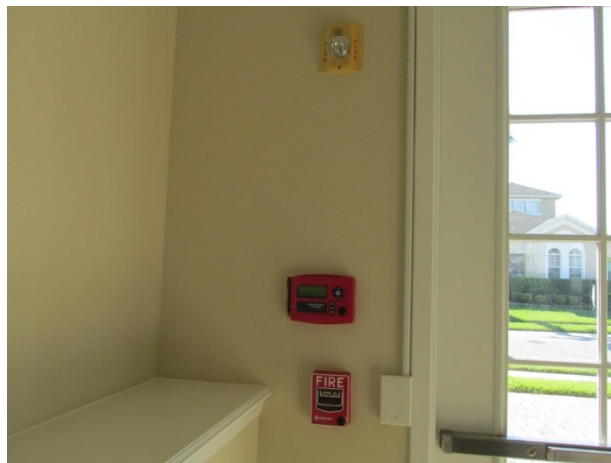
Conditions: Reported satisfactory

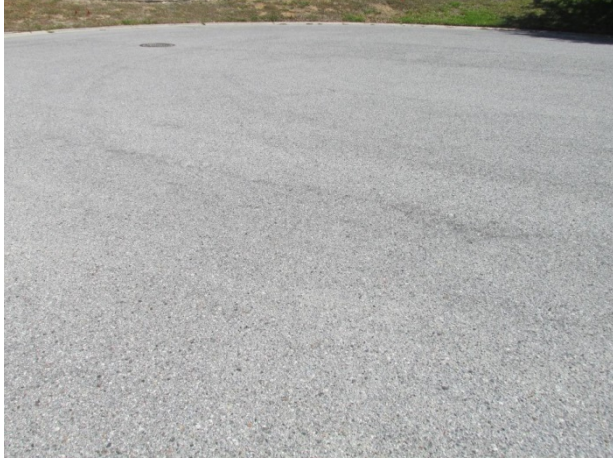
Condition: Good to fair overall with isolated cracks, settlement, vehicular stains and delamination evident

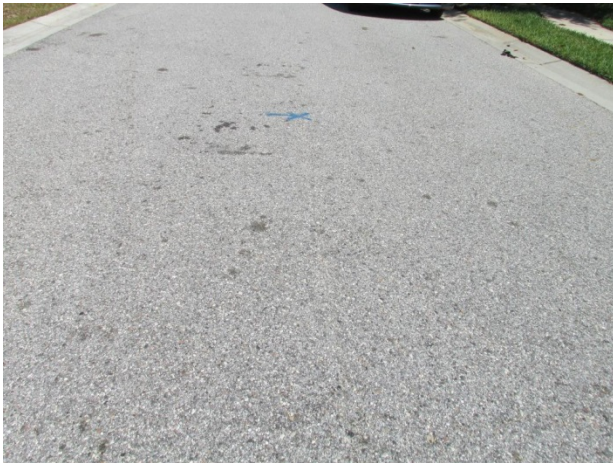
Vehicular stains evident

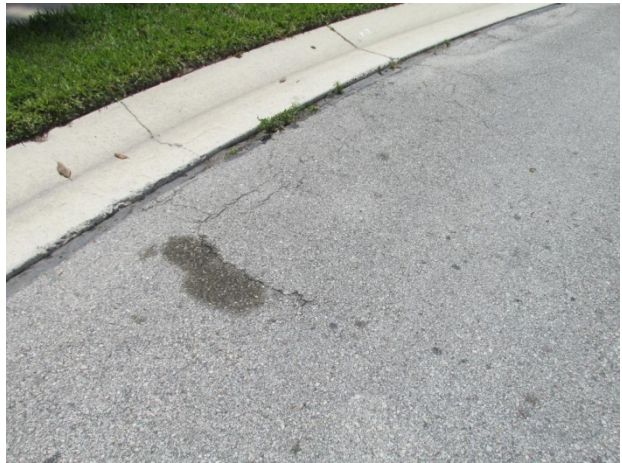
Cracks and settlement evident

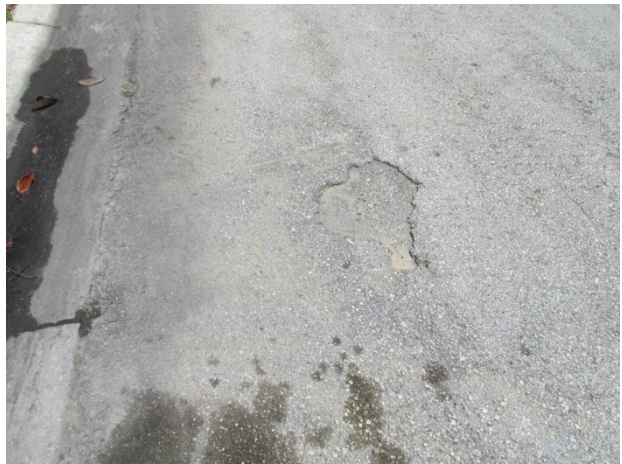
Delamination evident

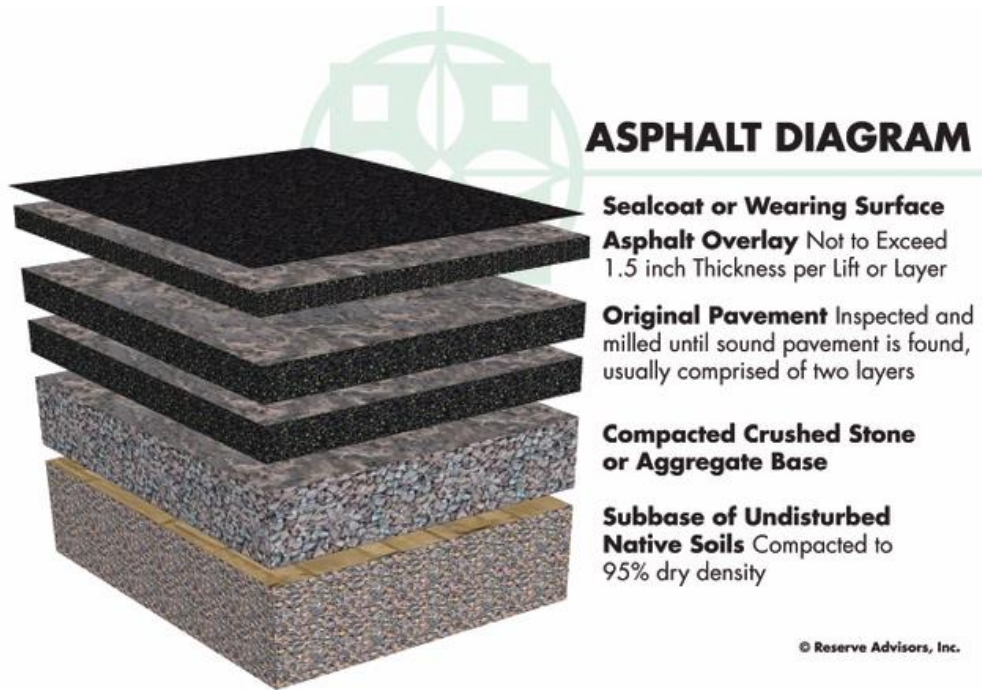
Component Detail Notes: The initial installation of asphalt uses at least two lifts, or two separate applications of asphalt, over the base course. The first lift is the binder course. The second lift is the wearing course. The wearing course comprises a finer aggregate for a smoother more watertight finish. The following diagram depicts the typical components although it may not reflect the actual configuration at Calabay Parc at Tower Lake:

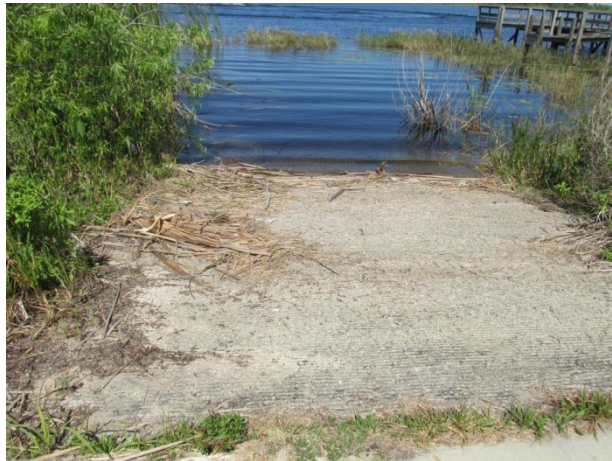
Condition: Good overall

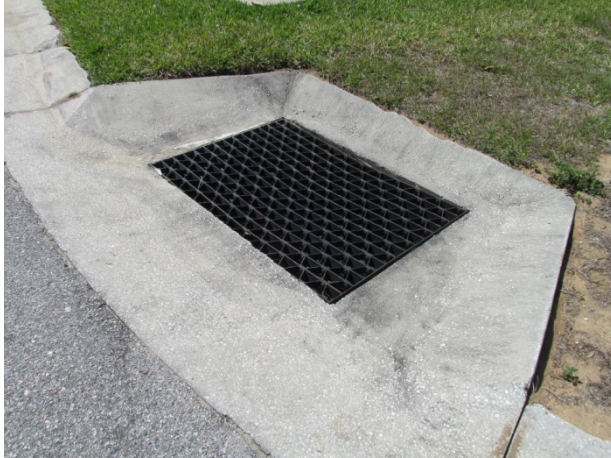
Condition: Good overall without settlement visually apparent. We note cracks.

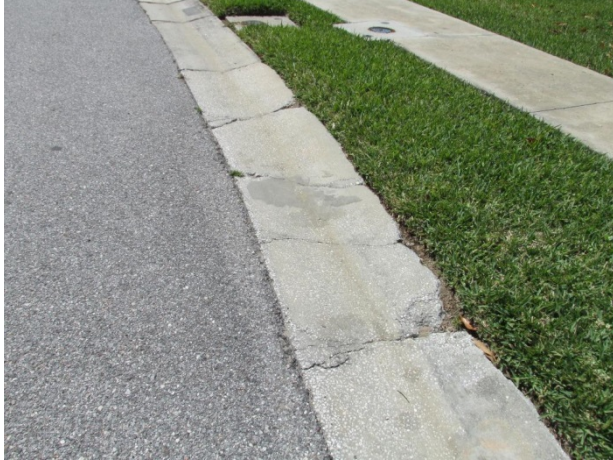
Condition: Good to fair overall with cracks evident

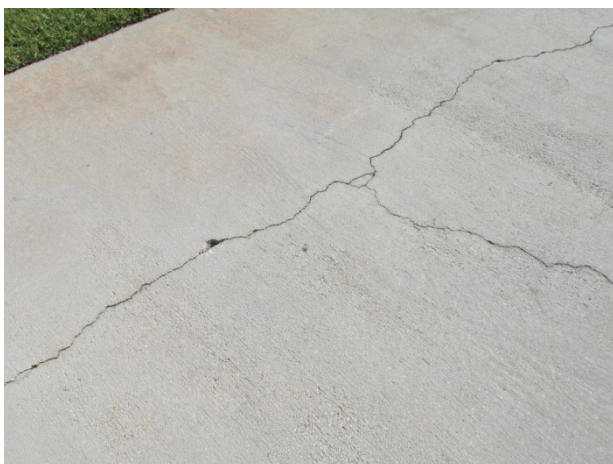
Cracks evident at driveway to boat ramp

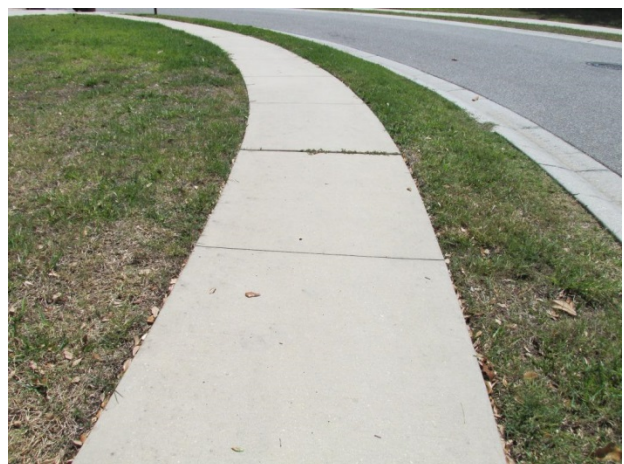
Typical concrete sidewalk

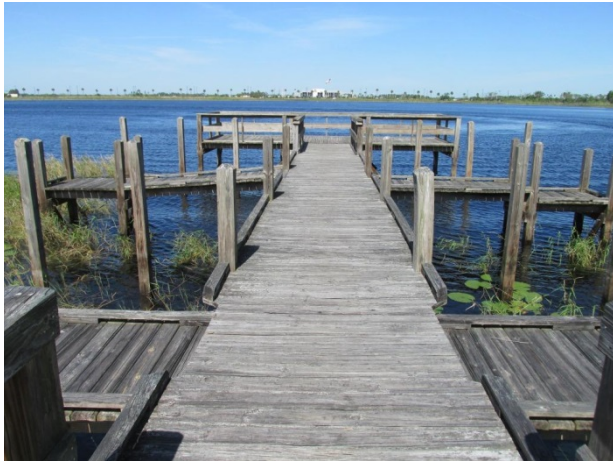
Condition: Poor condition with wood deterioration and warp evident

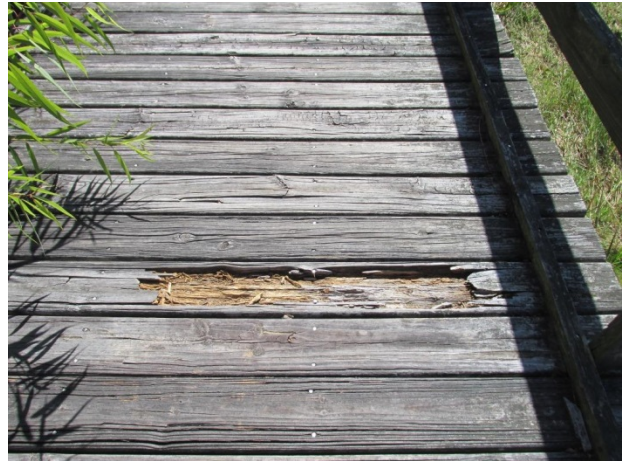
Wood deterioration evident

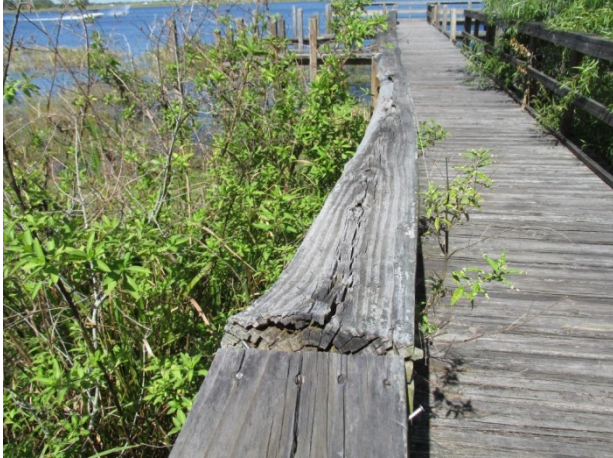
Wood deterioration evident

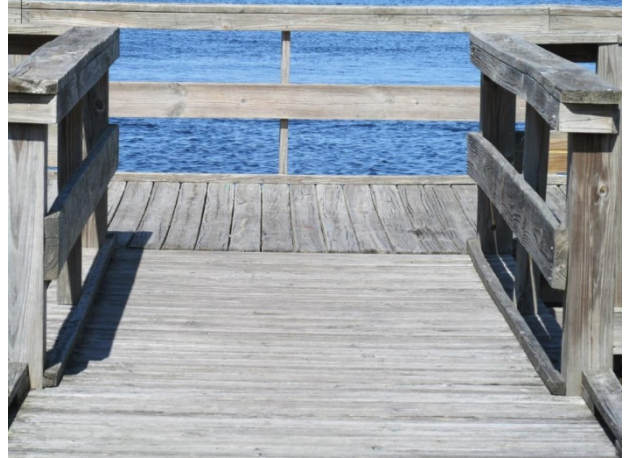
Warp evident at deck boards

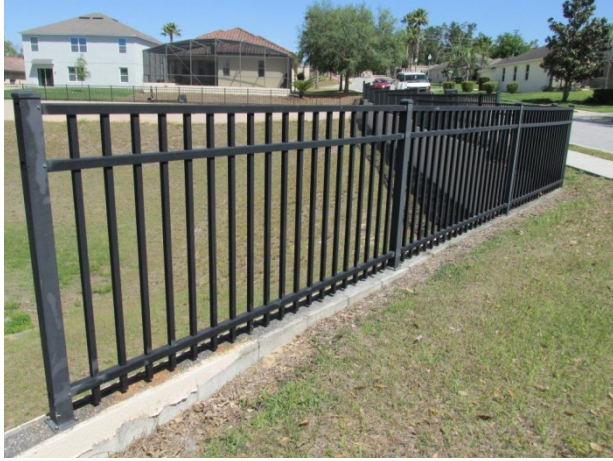
Fence on Tower Lake Boulevard

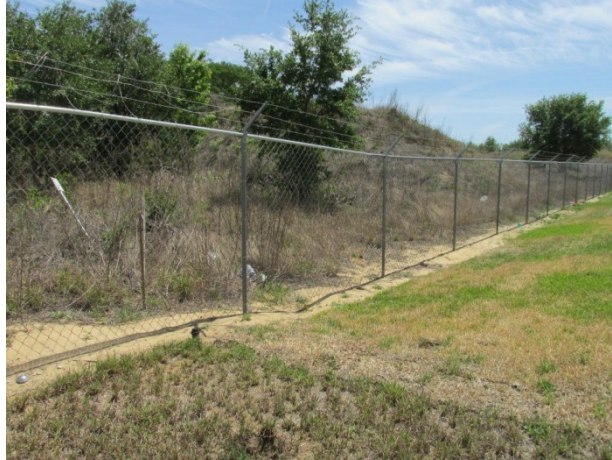
Condition: Good overall

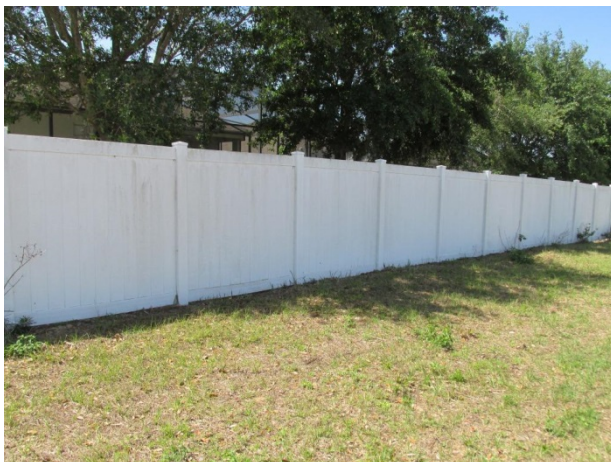
Condition: Good overall

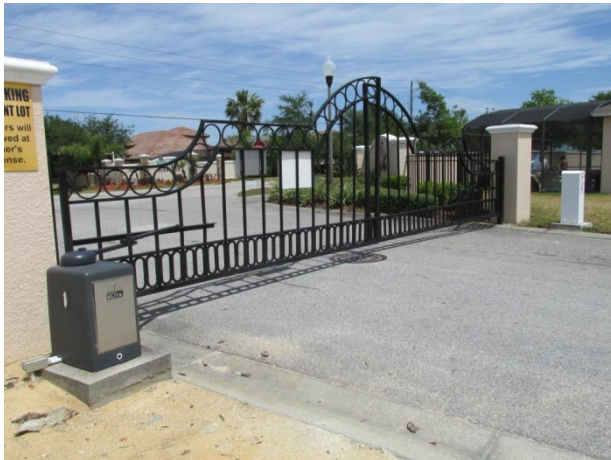
Resident entrance gates and operators

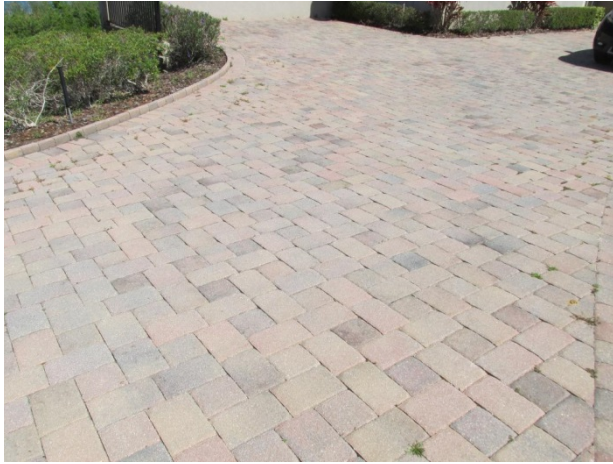
Condition: Good to fair overall with vehicular stains evident

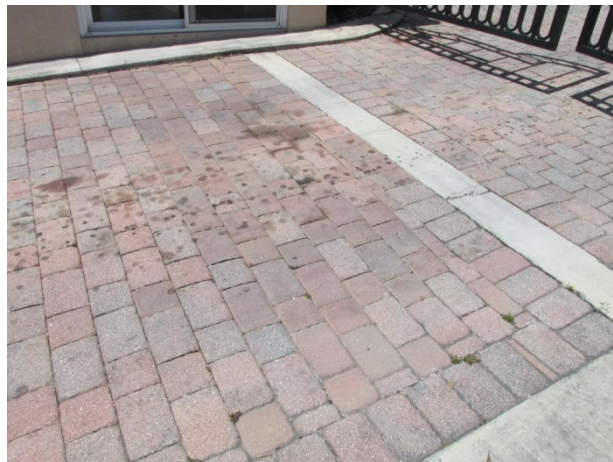
Pavers at entrance with vehicular stains

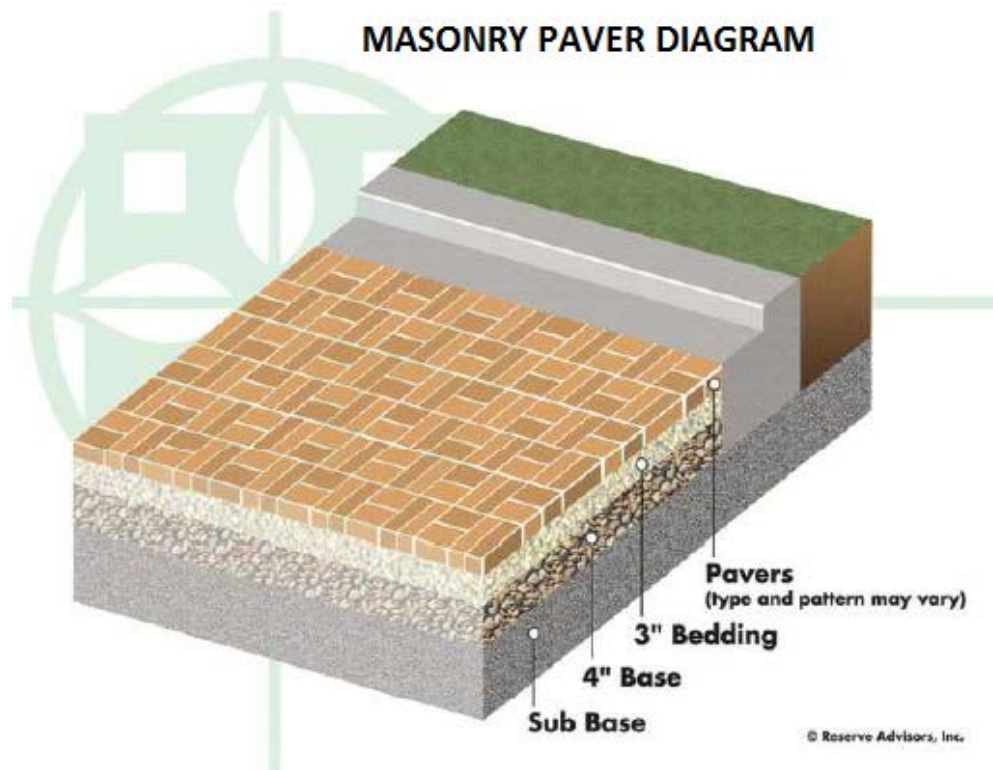
Priority/Criticality: Not recommended to defer

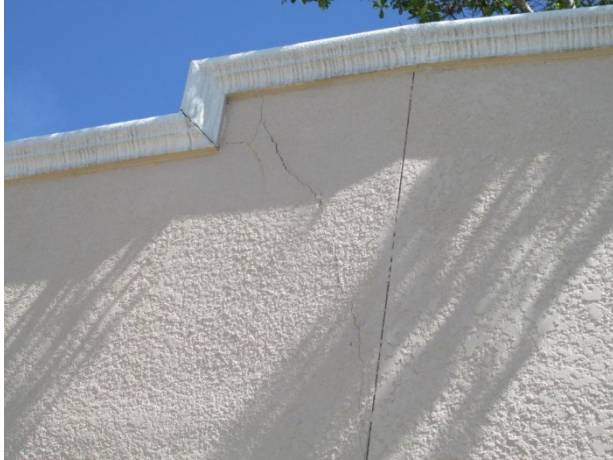
Stucco cracks evident

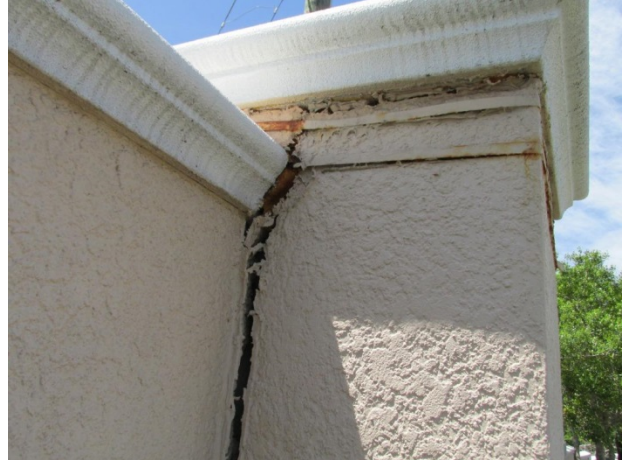
Sealant cracks and rust at coping evident

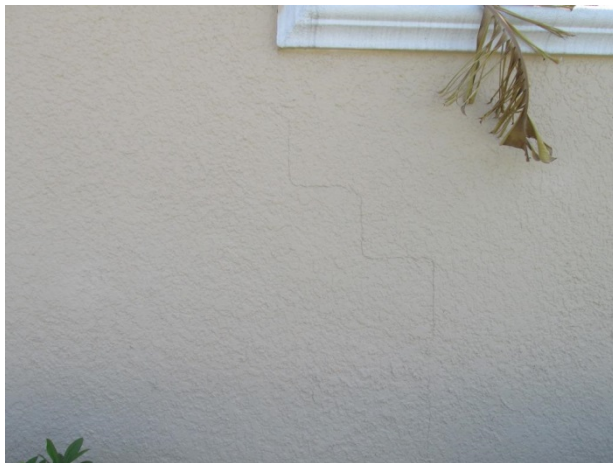
Stucco cracks evident

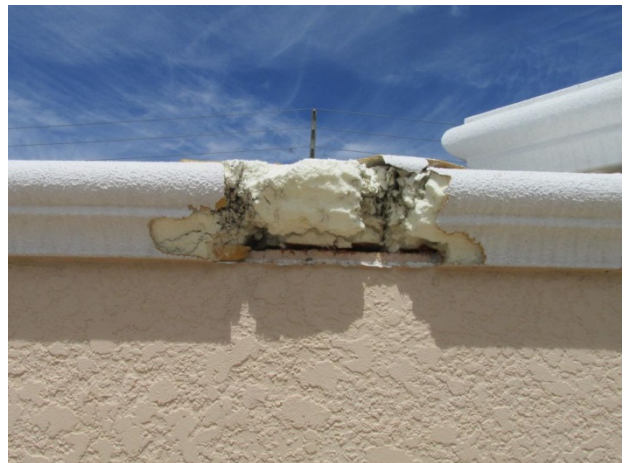
Coping damage evident

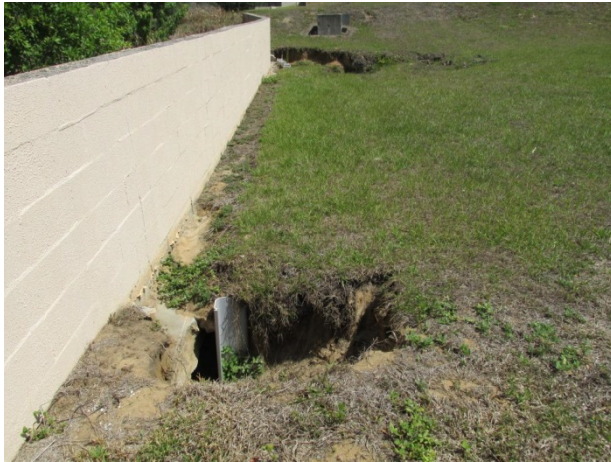
Erosion in detention pond near Tower Lake

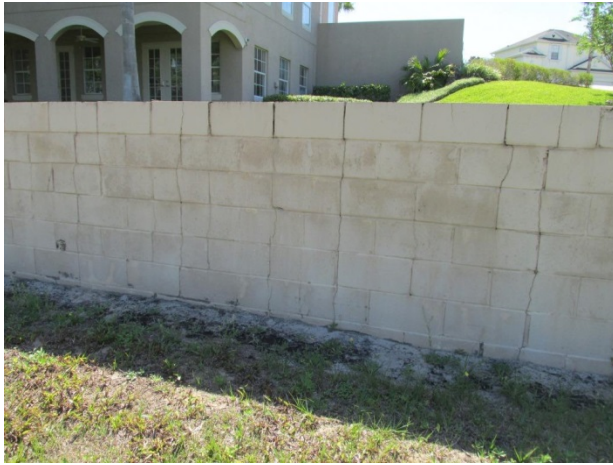
Condition: Good to fair overall with cracks evident

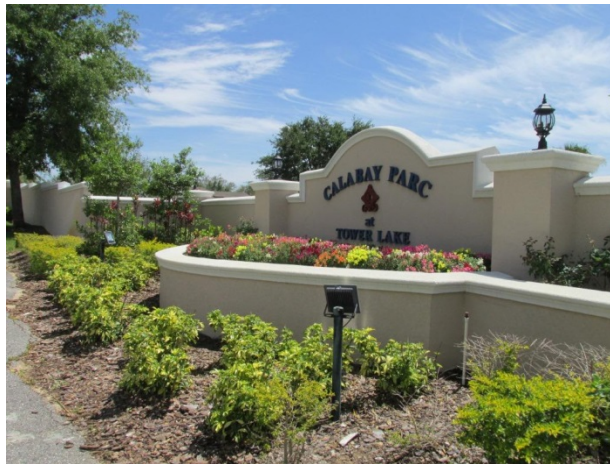
Condition: Good overall
